Debris/Ice/TPS Assessment and Integrated Photographic Analysis for Shuttle Mission STS-58

January 1994

Gregory N. Katnik
NASA/Kennedy Space Center

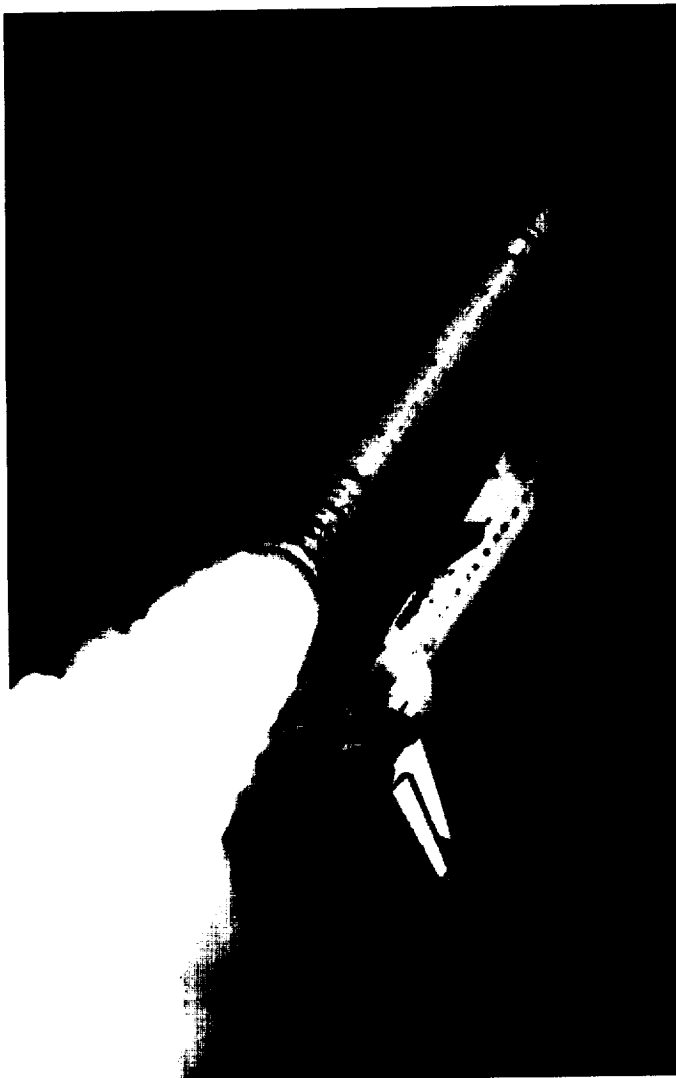
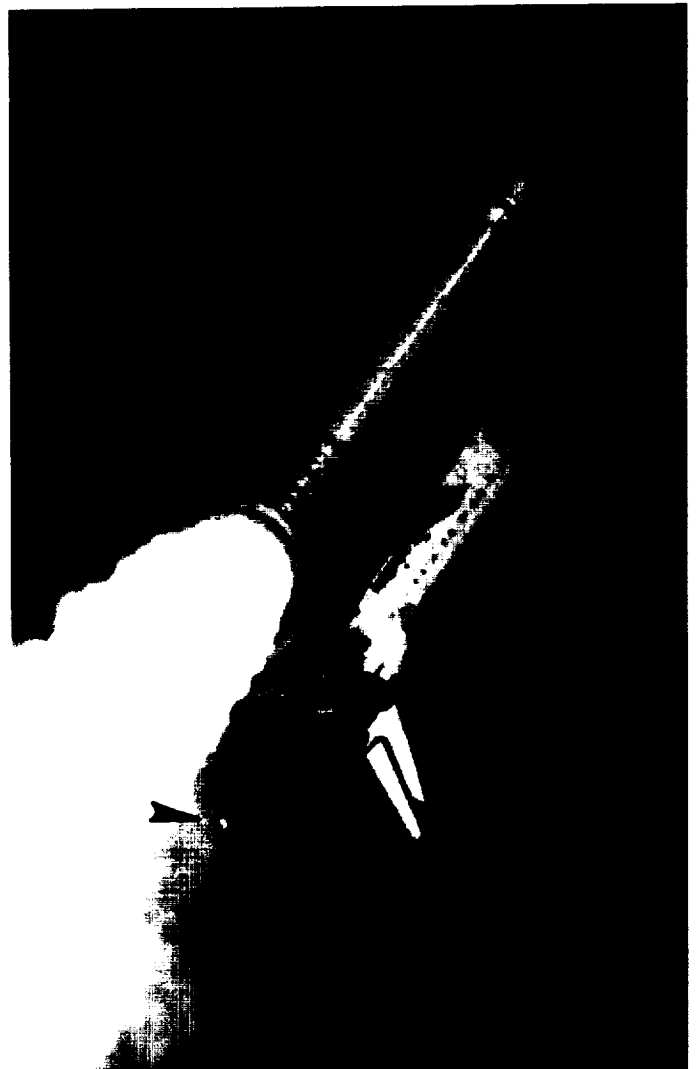
A white object, believed to be a Dome Mounted Heat Shield closeout blanket MR patch, fell aft of the vehicle 45 seconds MET. The object originated between SSME #2 and #3, got caught in plume recirculation near the base heat shield, and passed the exit plane of SSME #1 before falling away from the vehicle.

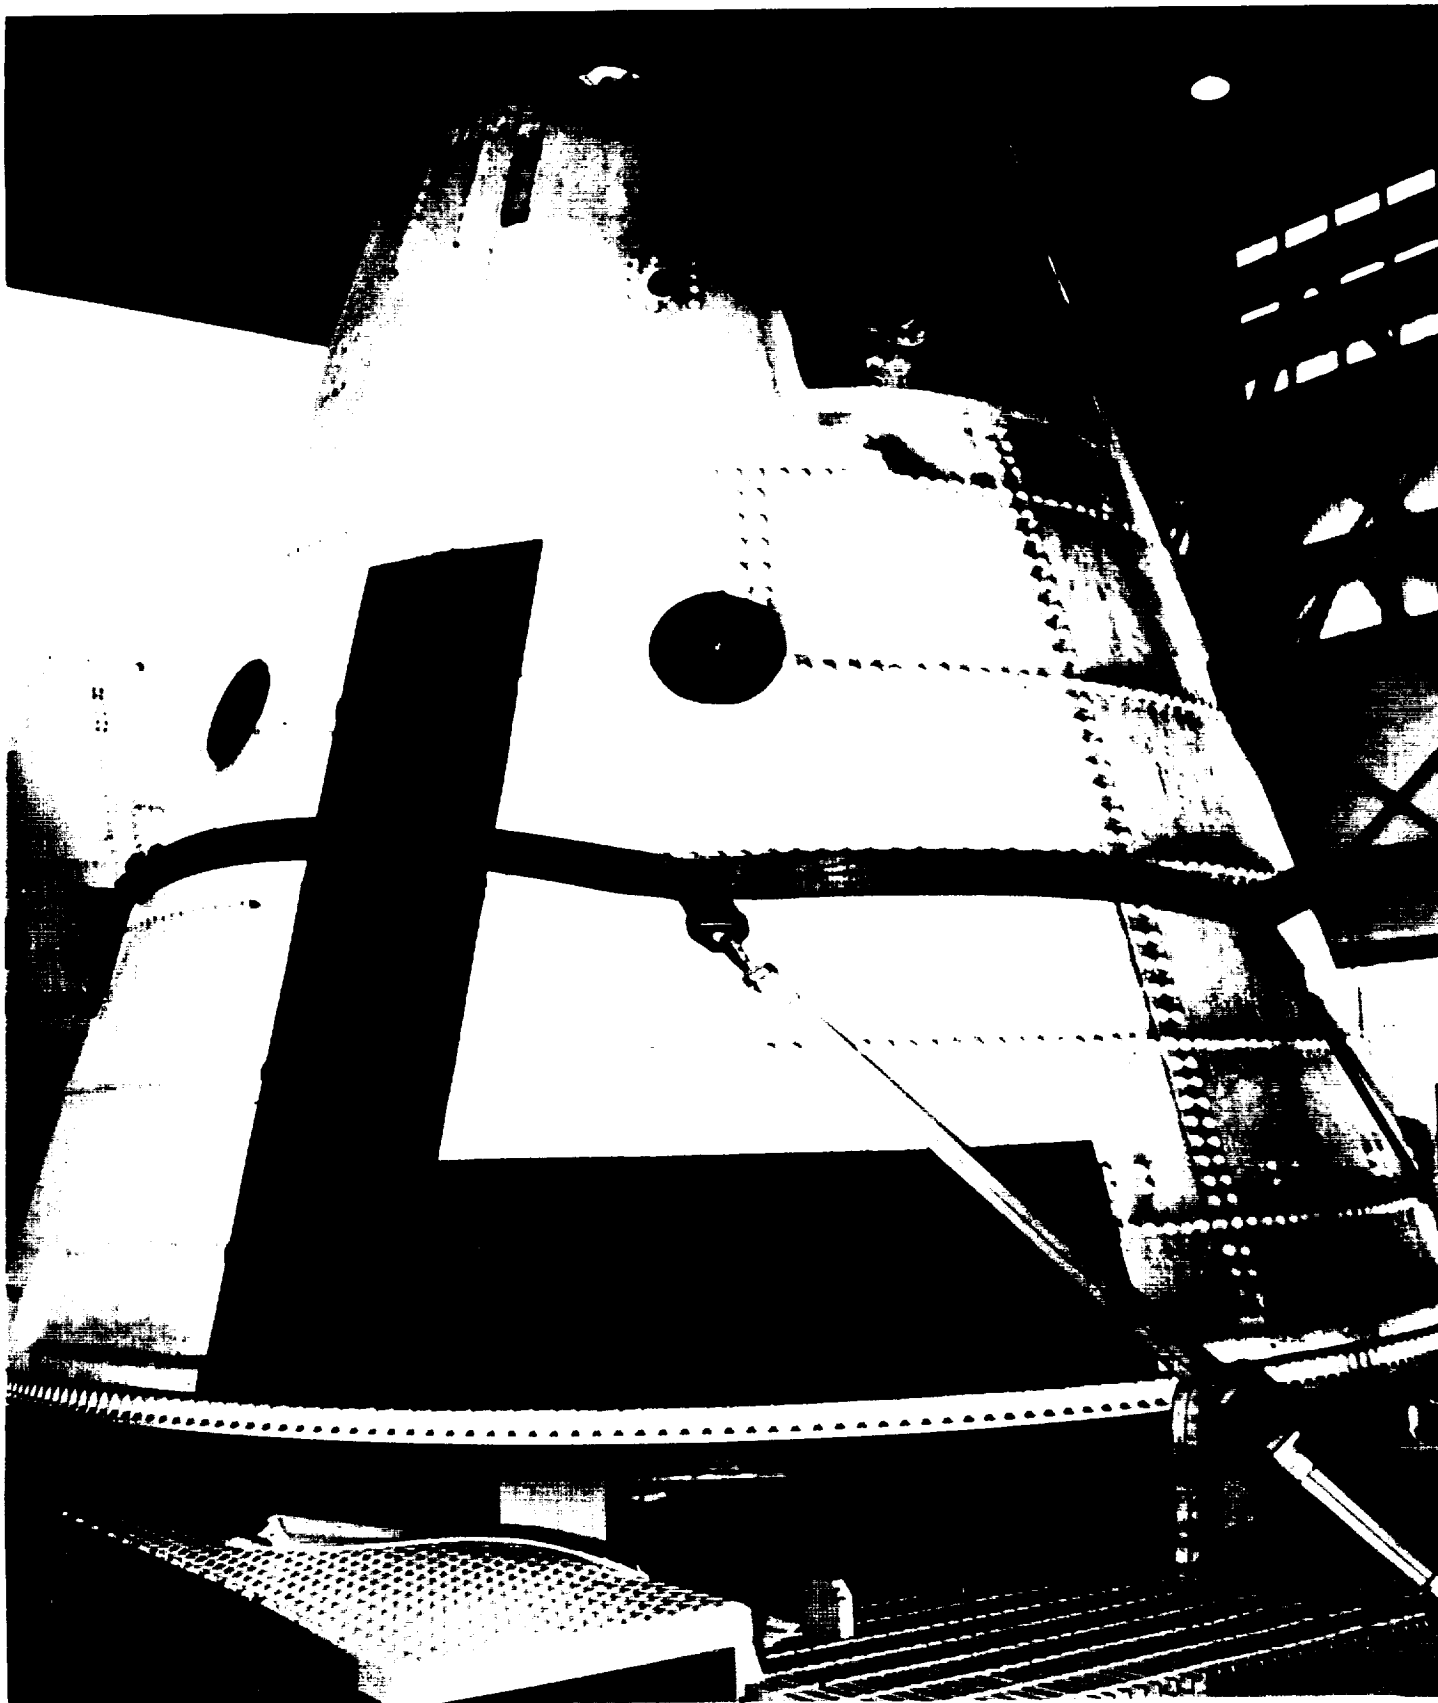
The RH frustum was missing no TPS, but had 20 MSA-2 debonds over fasteners. Minor blistering of the Hypalon paint occurred in localized areas.

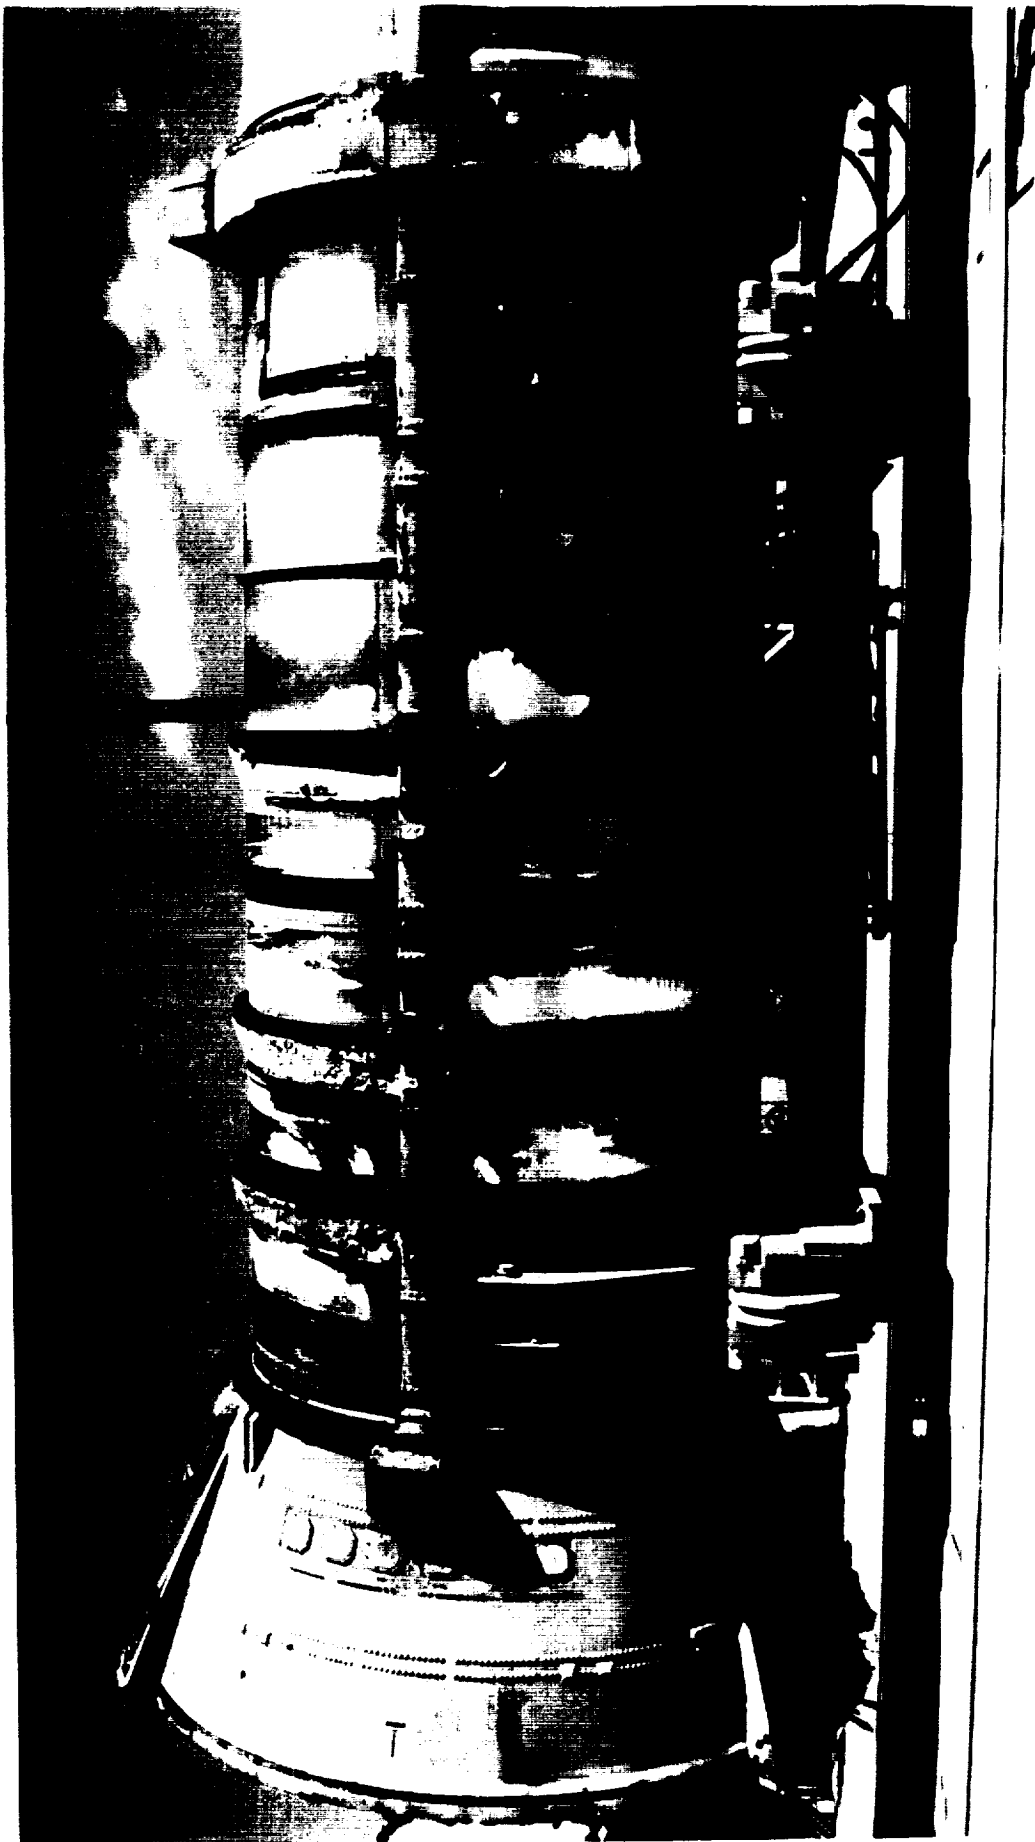
Post flight condition of the RH aft booster and aft skirt. The ET/SRB aft struts, ETA ring, IEA, and IEA covers appeared undamaged though foam was missing from the aft side of the ETA ring. Charring of adjacent material indicated the foam was lost in flight rather than at water impact.

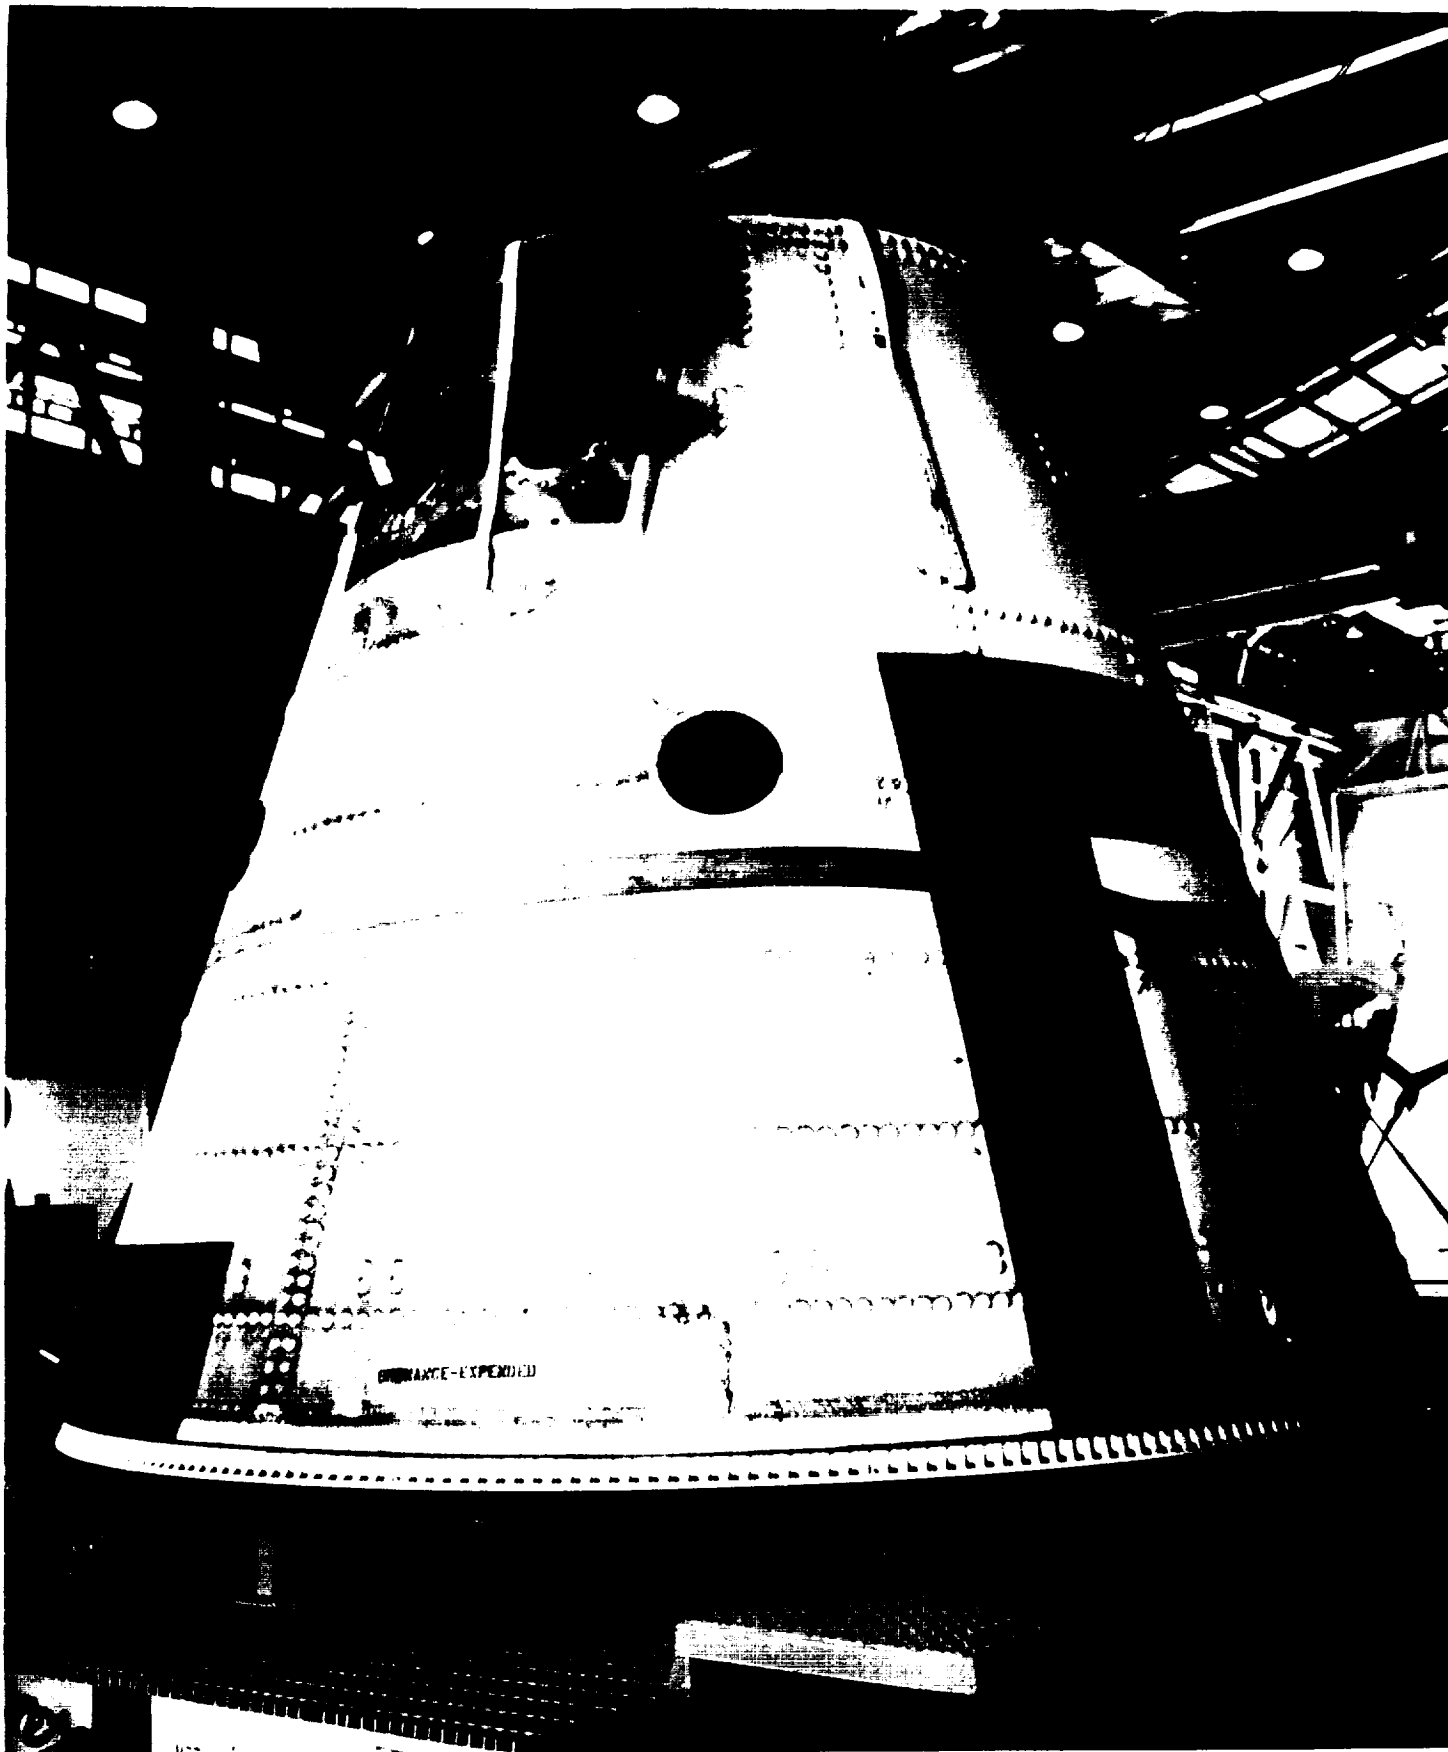
The LH frustum was missing no TPS, but had a total of 34 MSA-2 debonds over fasteners. The BSM aero heatshield covers were locked in the fully opened position.

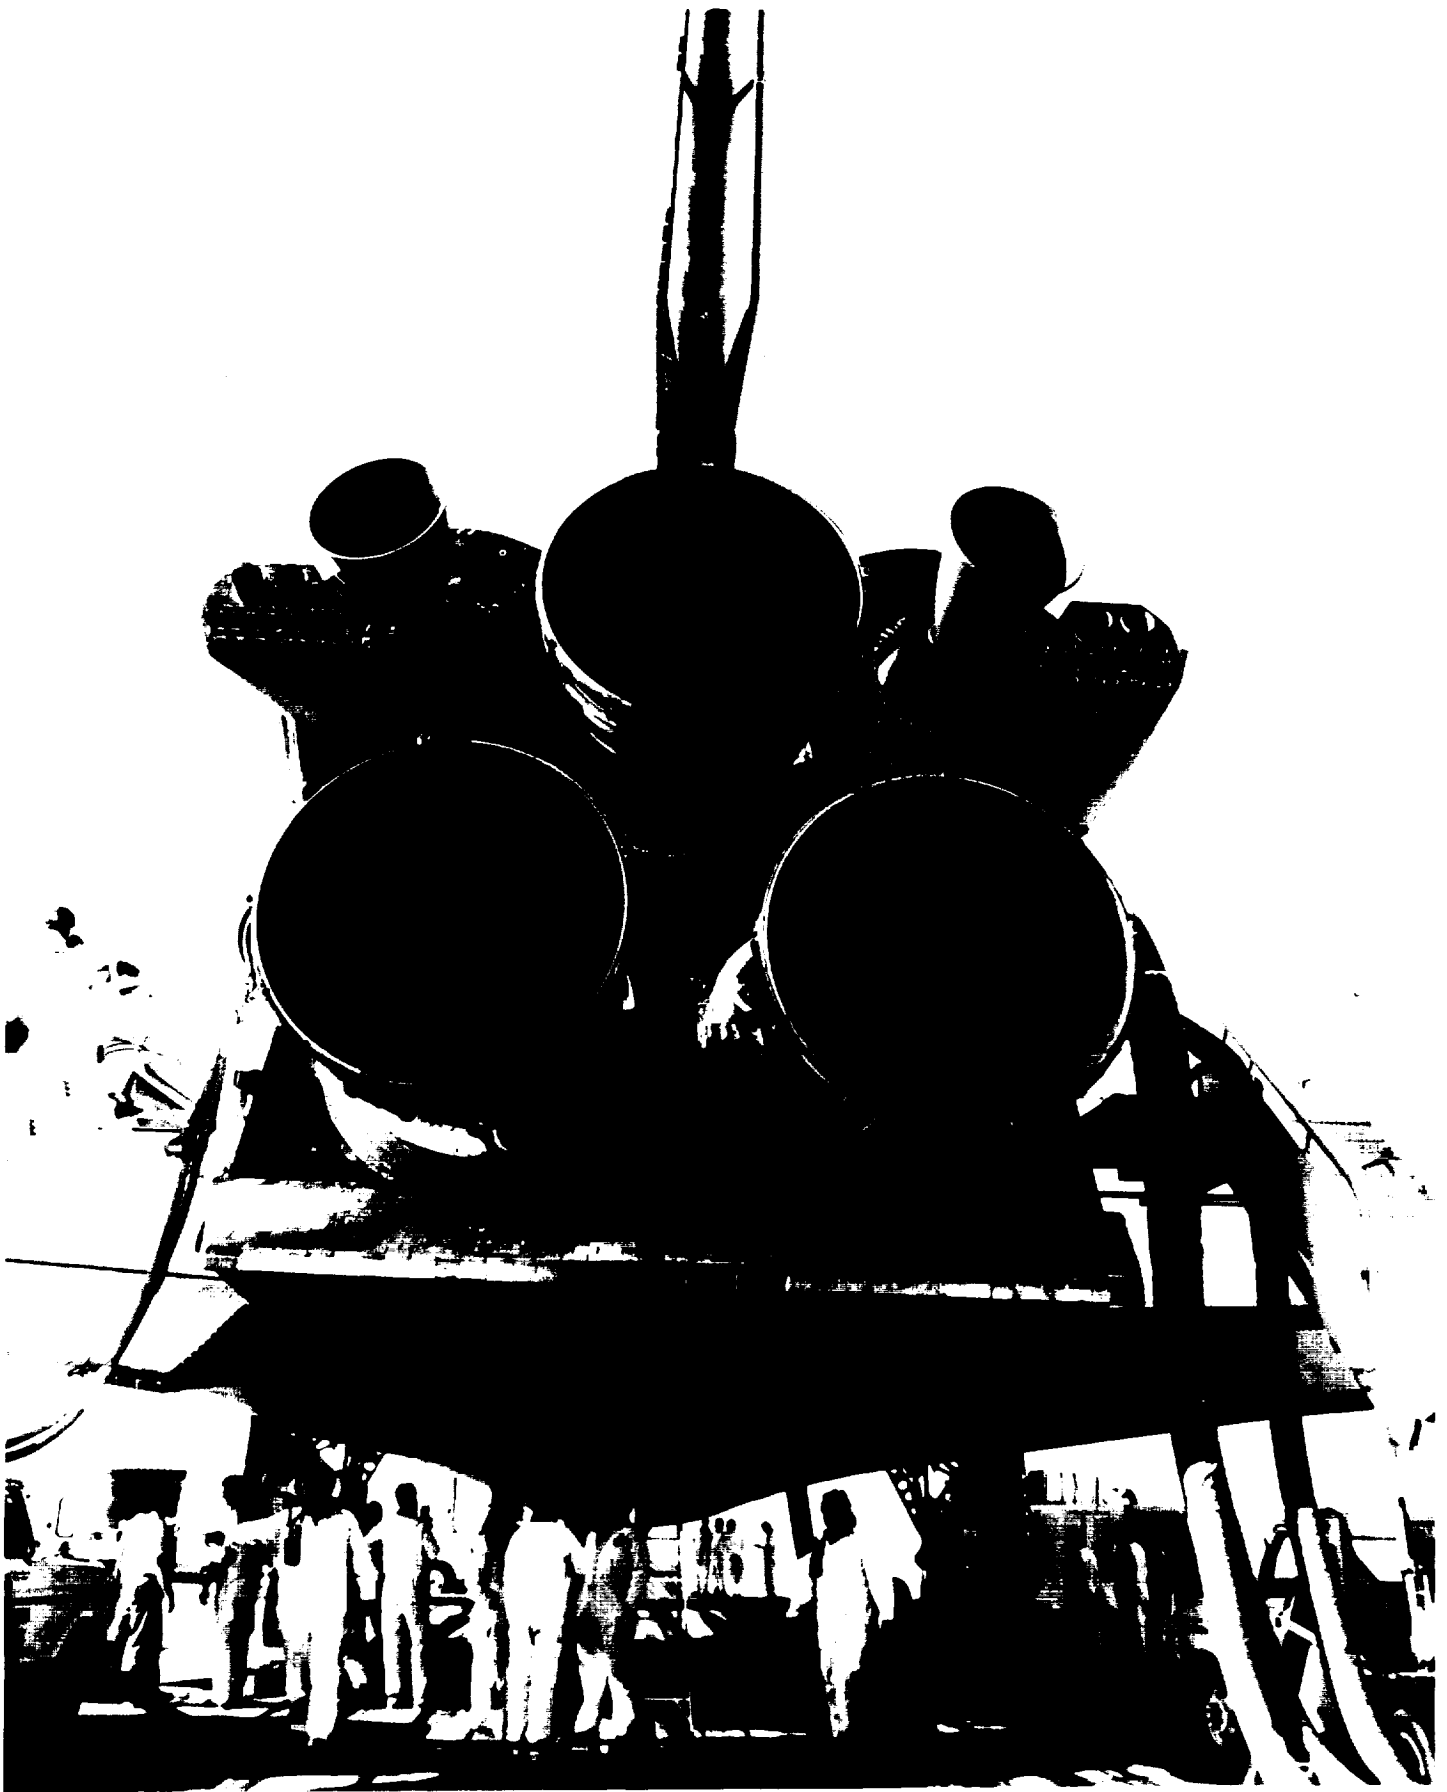
Overall view of base heat shield and SSME's. Tile damage on the base heat shield was less than usual. Note damage to SSME #2 and #3 Dome Mounted Heat Shield closeout blankets.

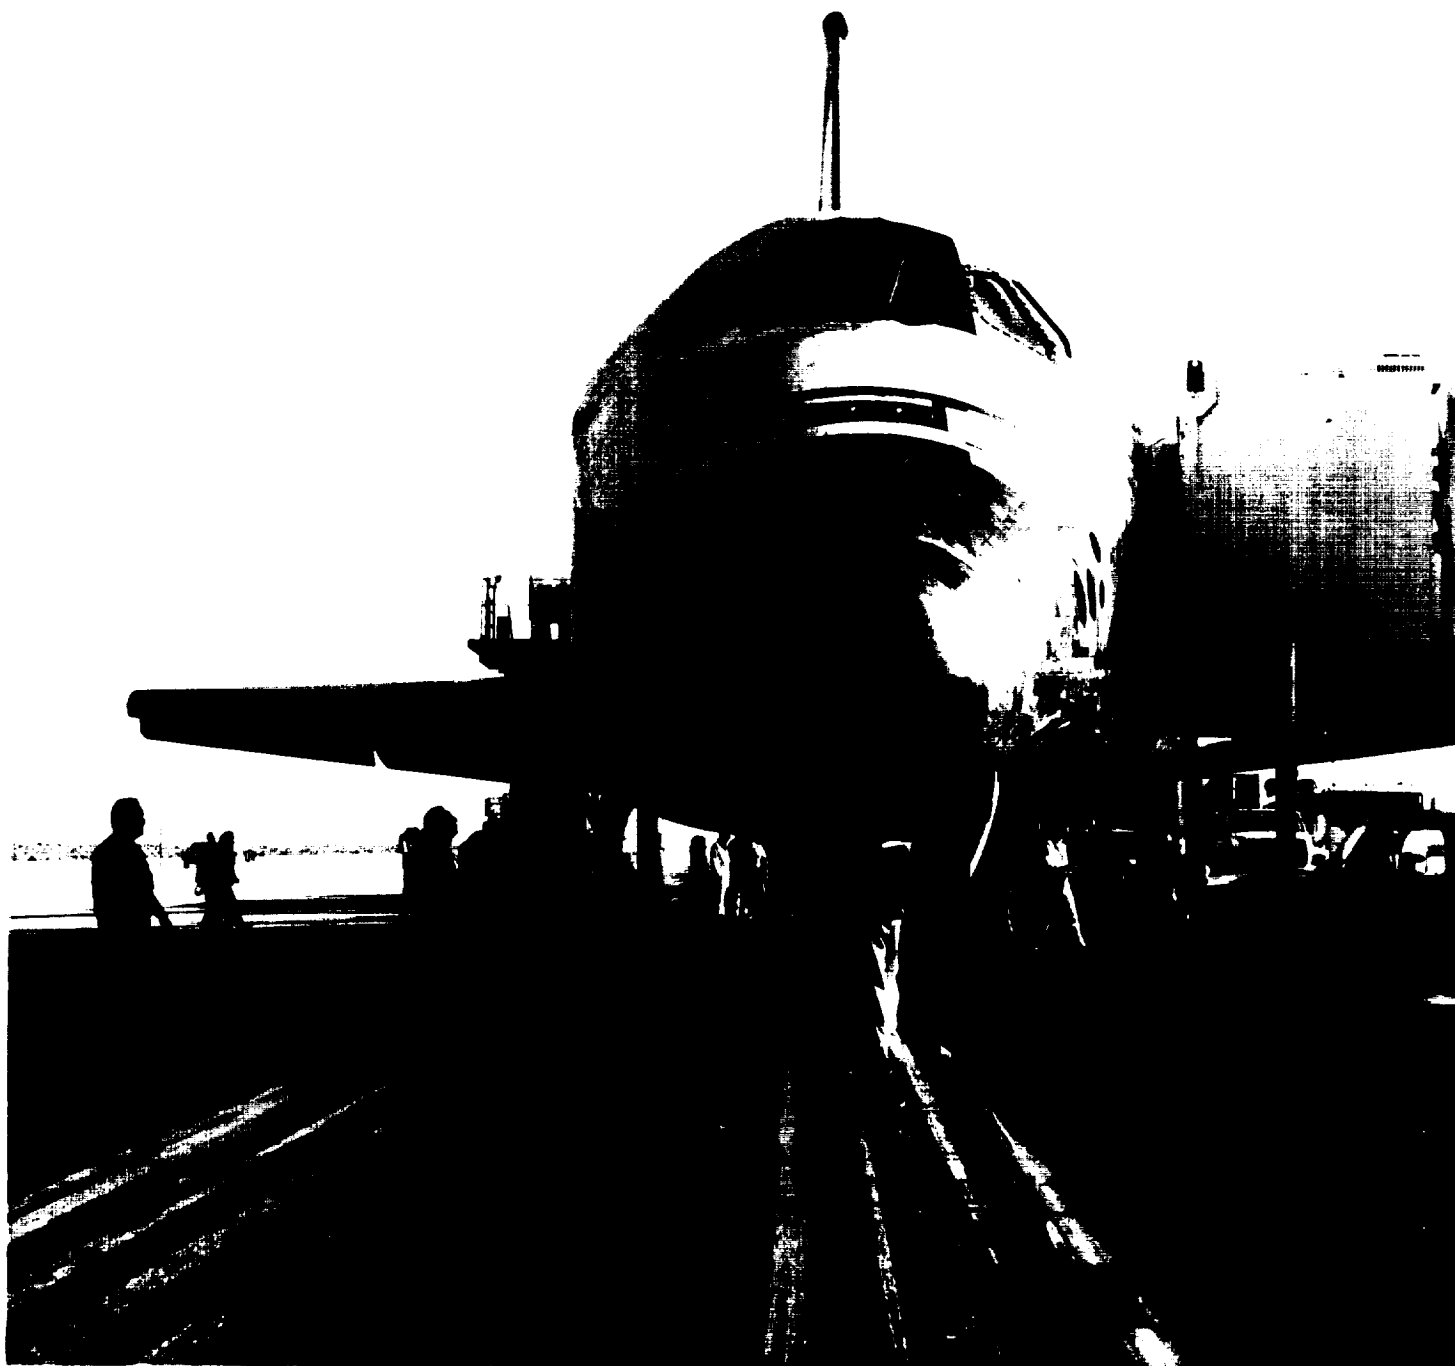
Overall view of Orbiter nose. Hazing on Orbiter forward facing windows was typical. Window #3 was hazed the most. Damage to window perimeter tiles was less than usual.
